**ROTO ROOTER**  
**PO BOX 3154**  
**BISMARCK ND 58502**  
**701-222-2653**

**Pipe Inspection Summary for Project: MIDWAY 14TH ADD. 2014-07**

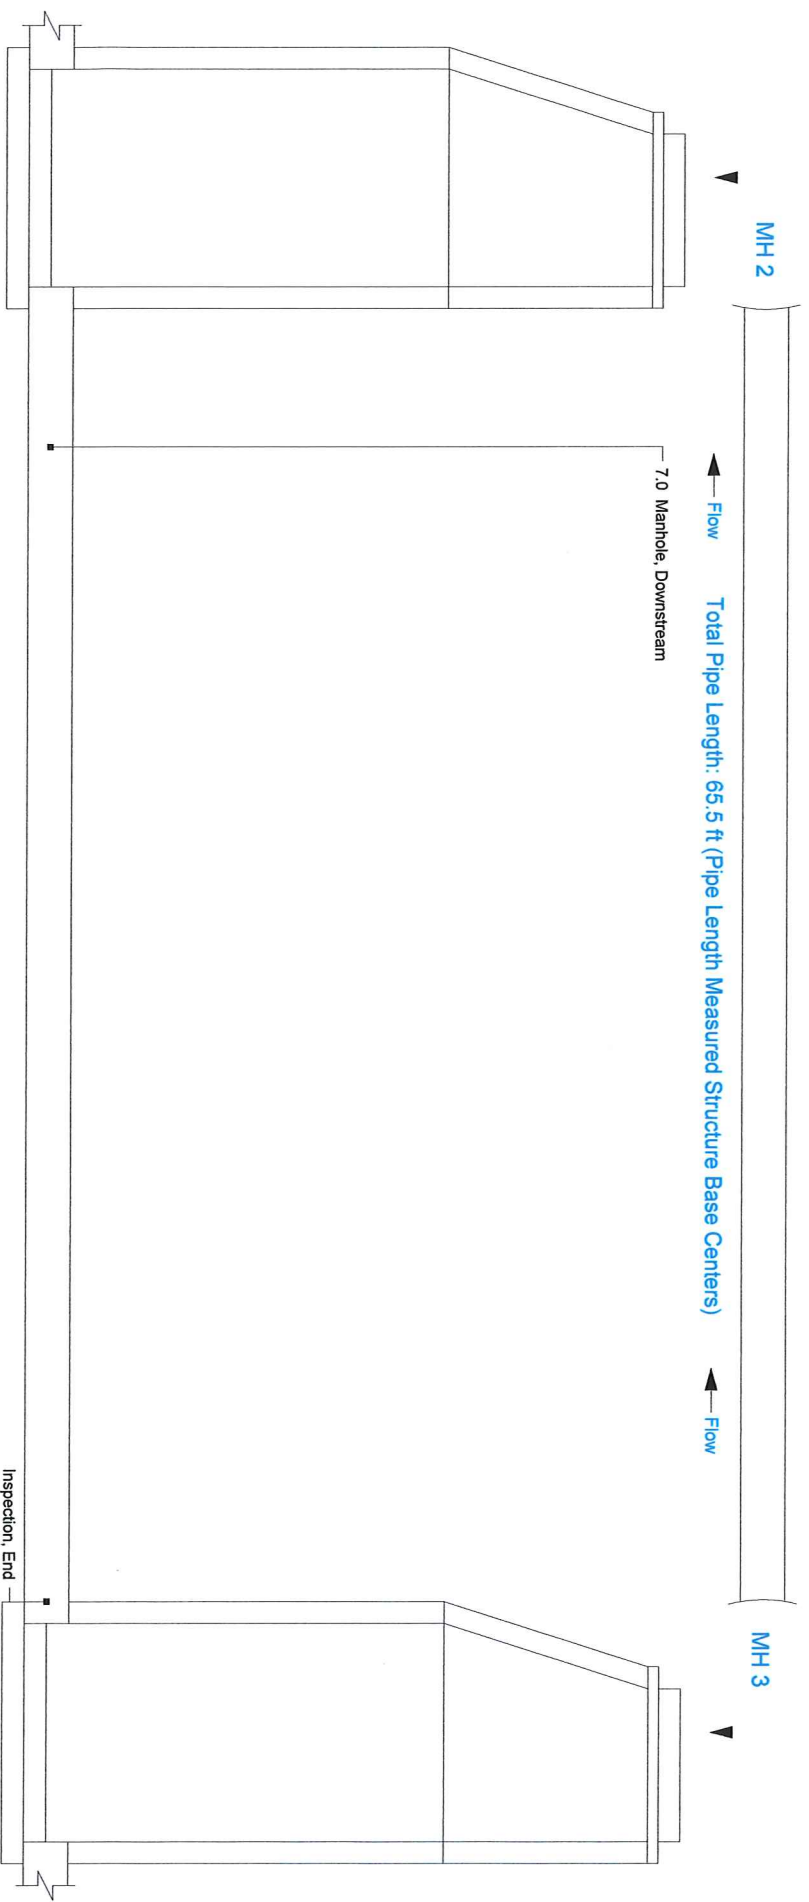
SCHEMATIC CROSS SECTION (Not to Scale) - Sewer Reach: MH [MH 3] to MH [MH 2]

Ftg	End	Offset	Observation	Leak (gpm)	Rtng	Clk	Video
7.0			Manhole, Downstream				
65.5			Inspection, End C.O.

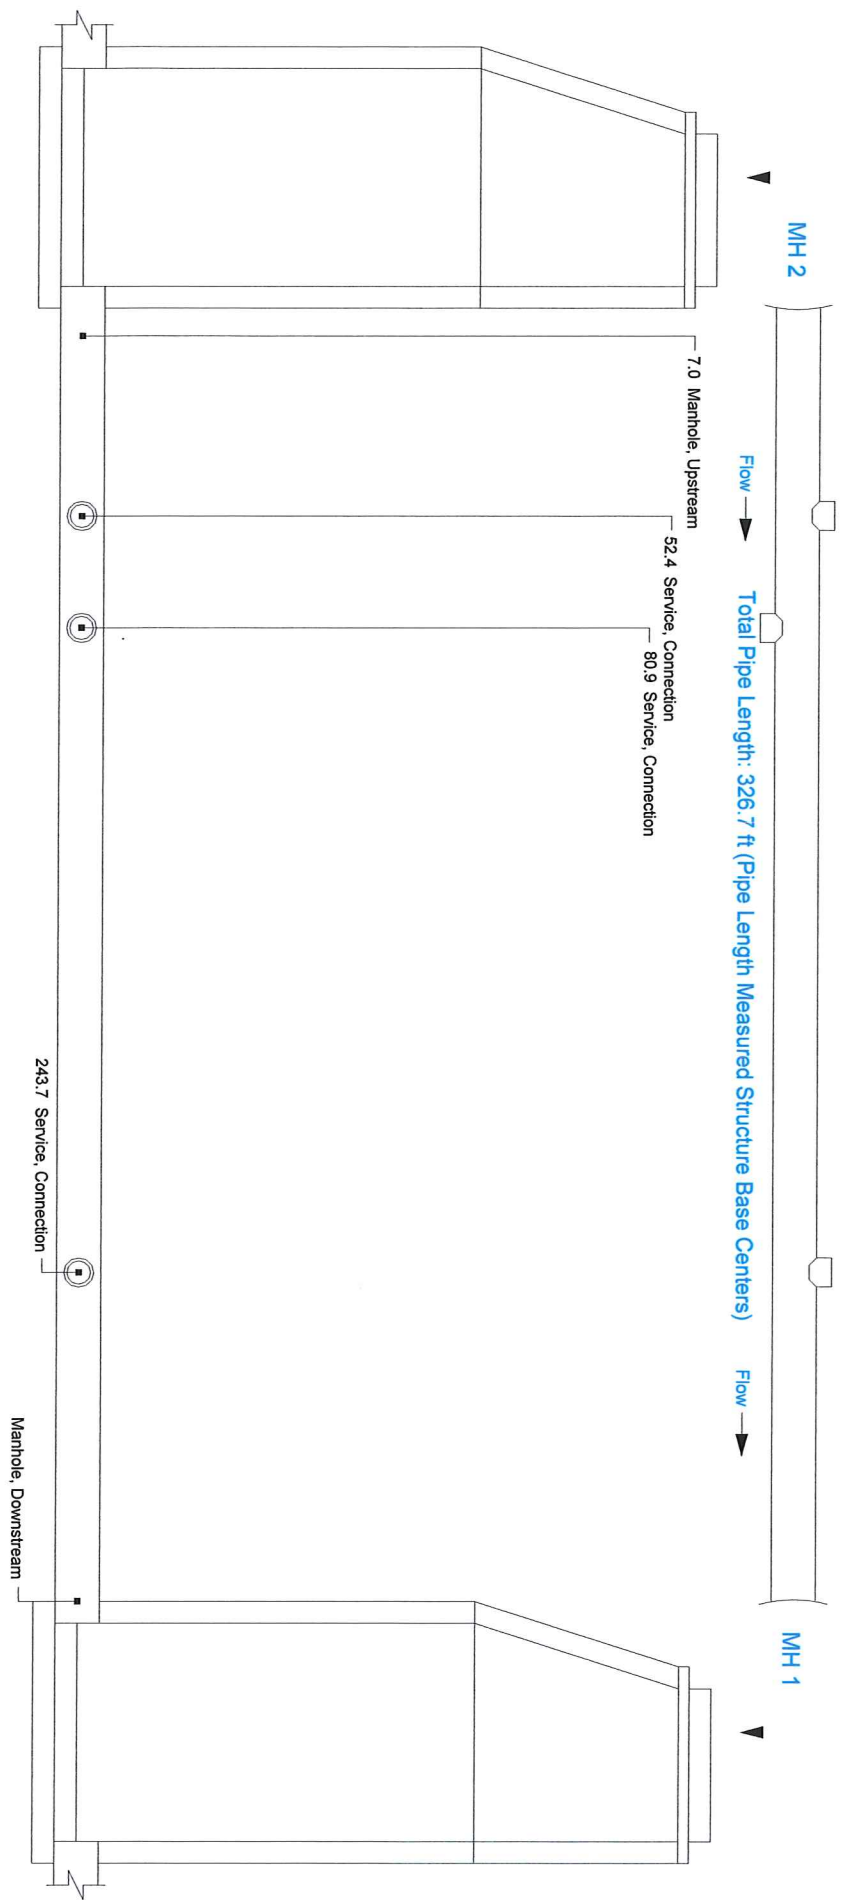
**SCHEMATIC CROSS SECTION (Not to Scale) - Sewer Reach: MH [MH 2] to MH [MH 1]**

Ftg	End	Offset Observation	Leak (gpm)	Rtng	Clk	Video
7.0		Manhole, Upstream				
52.4		Service, Connection			9	
80.9		Service, Connection			3	
243.7		Service, Connection			9	
326.7		Manhole, Downstream

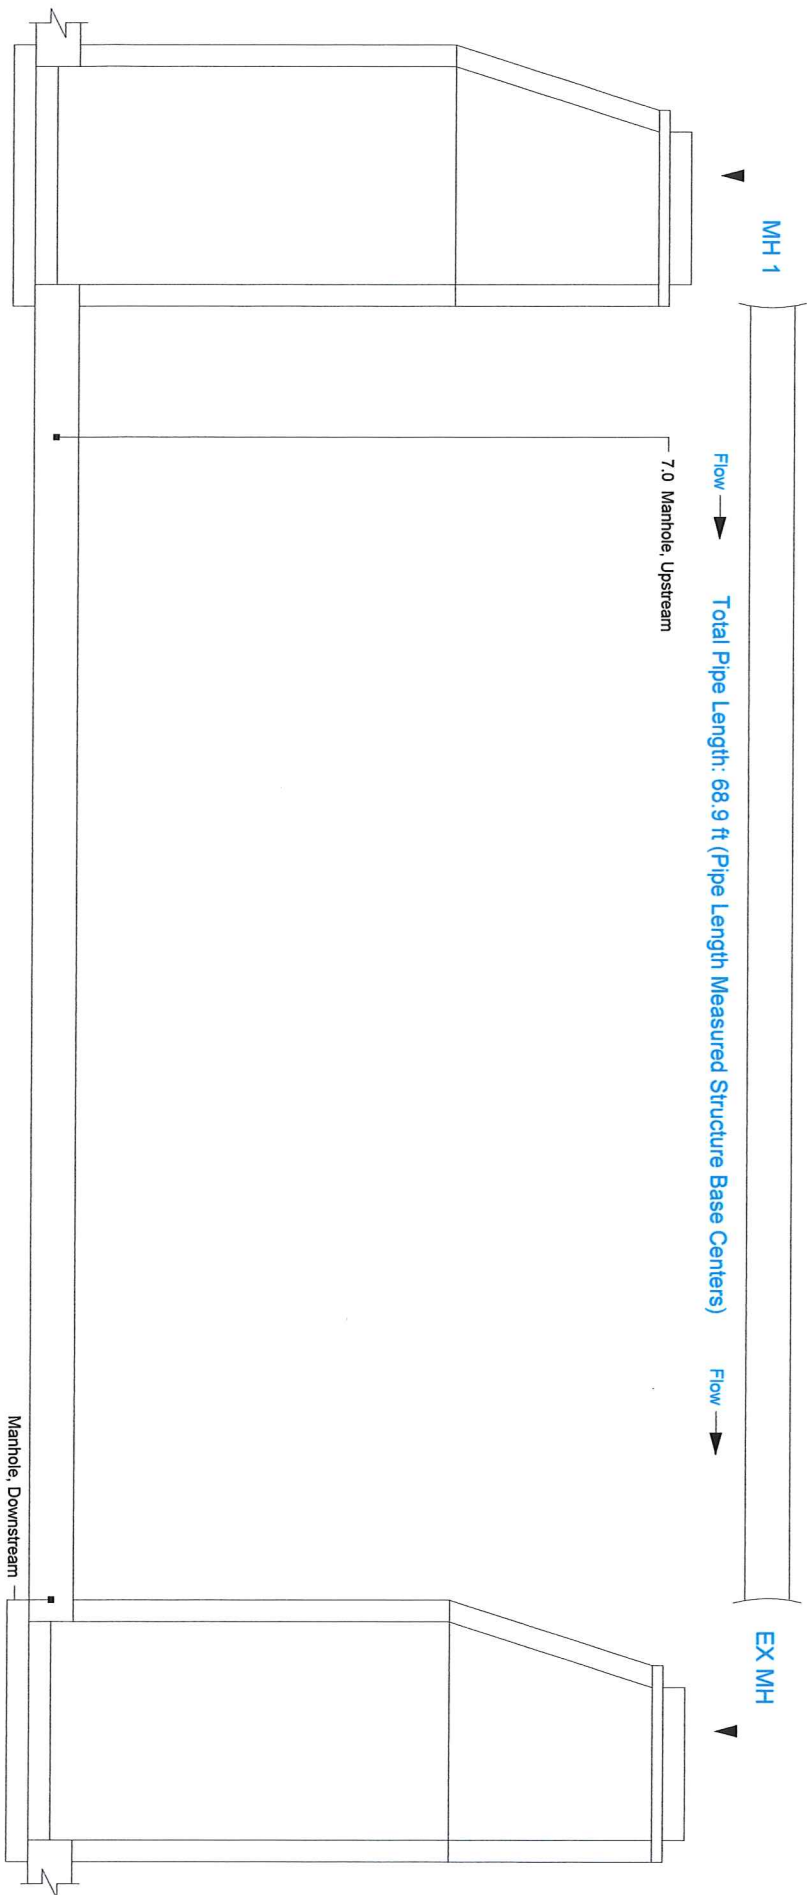
SCHEMATIC CROSS SECTION (Not to Scale) - Sewer Reach: MH [MH 1] to MH [EX MH ]

Ftg	End	Offset	Observation	Leak (gpm)	Rtng	Clk	Video
7.0			Manhole, Upstream				
68.9			Manhole, Downstream
