AS CONSTRUCTED  
 PHASE 1

MANDAN INTERCEPTOR 1983  
 MANDAN, NORTH DAKOTA

OLD RED TRAIL  
 STA. 0-10 TO STA. 4+38

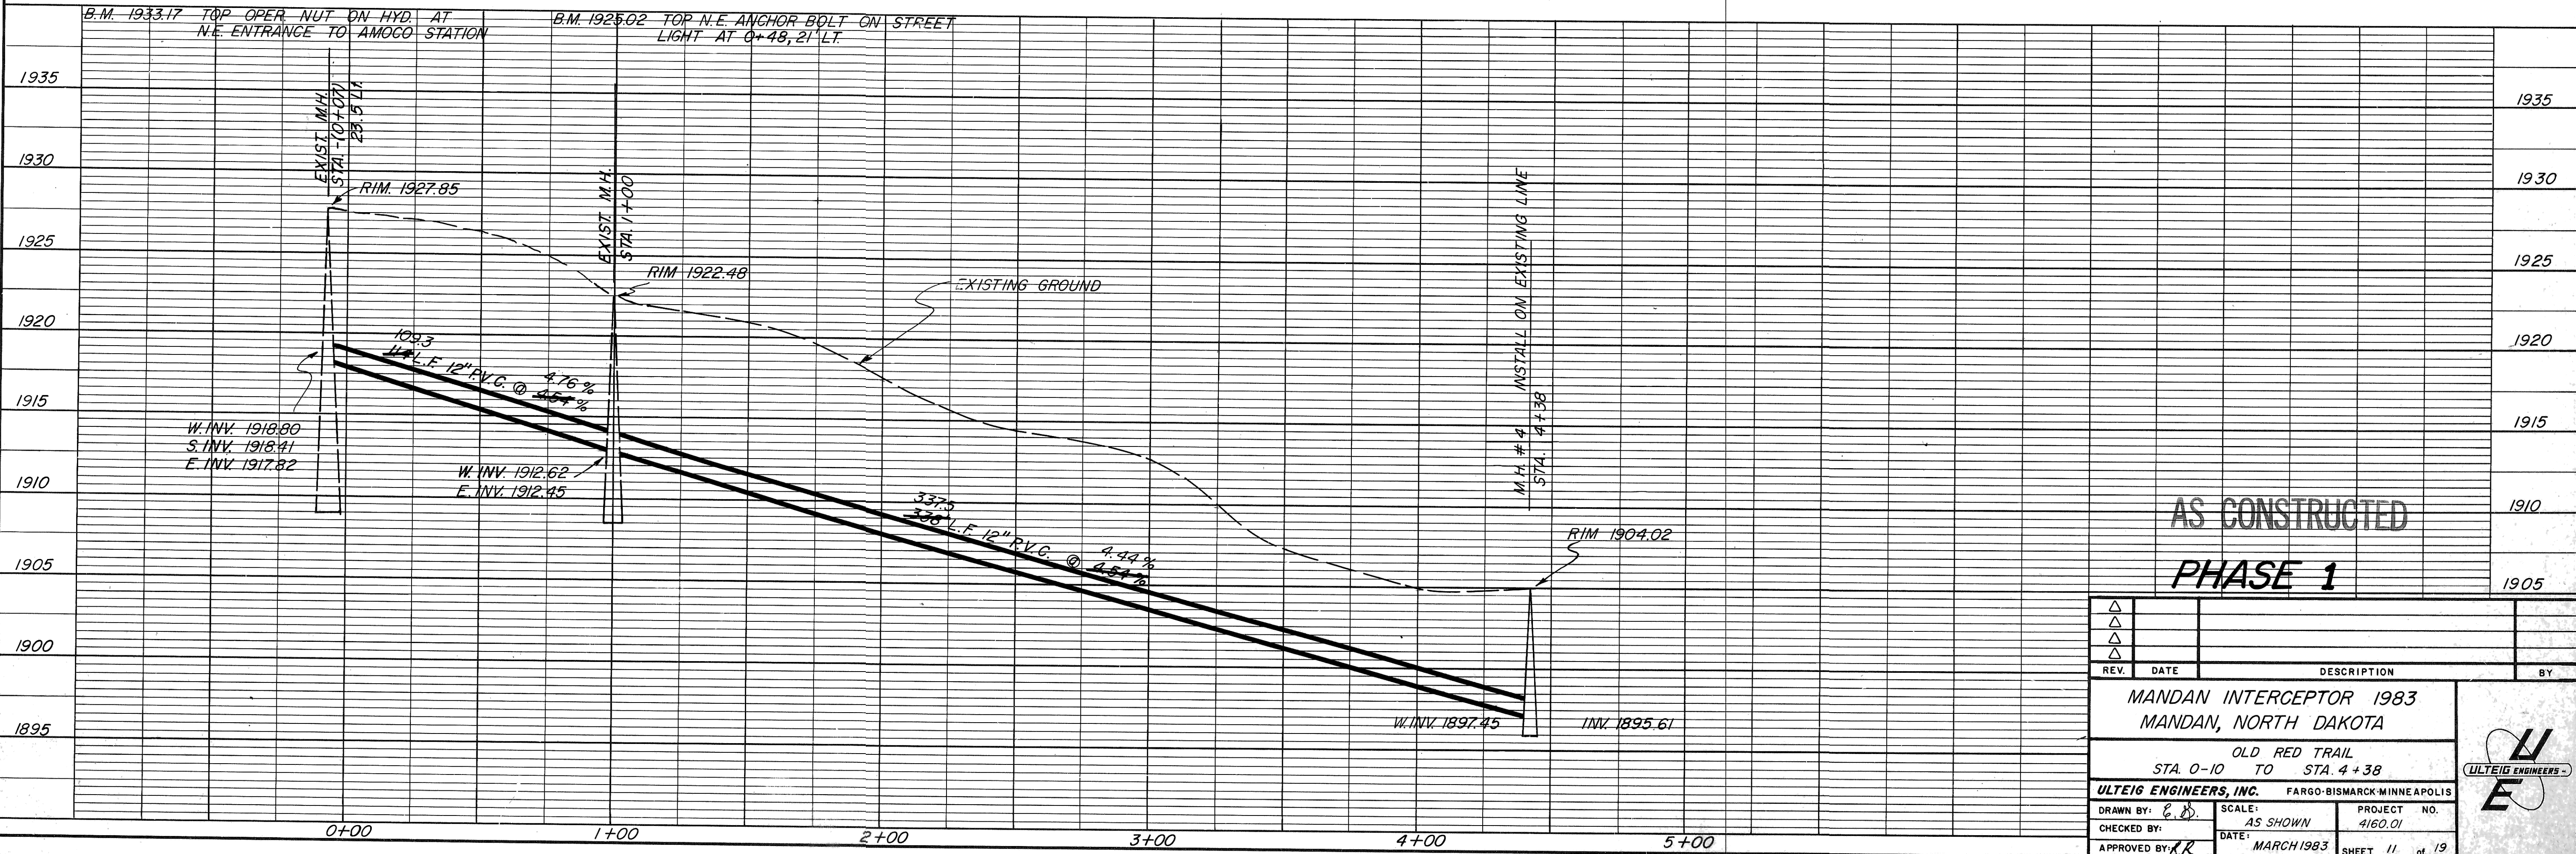
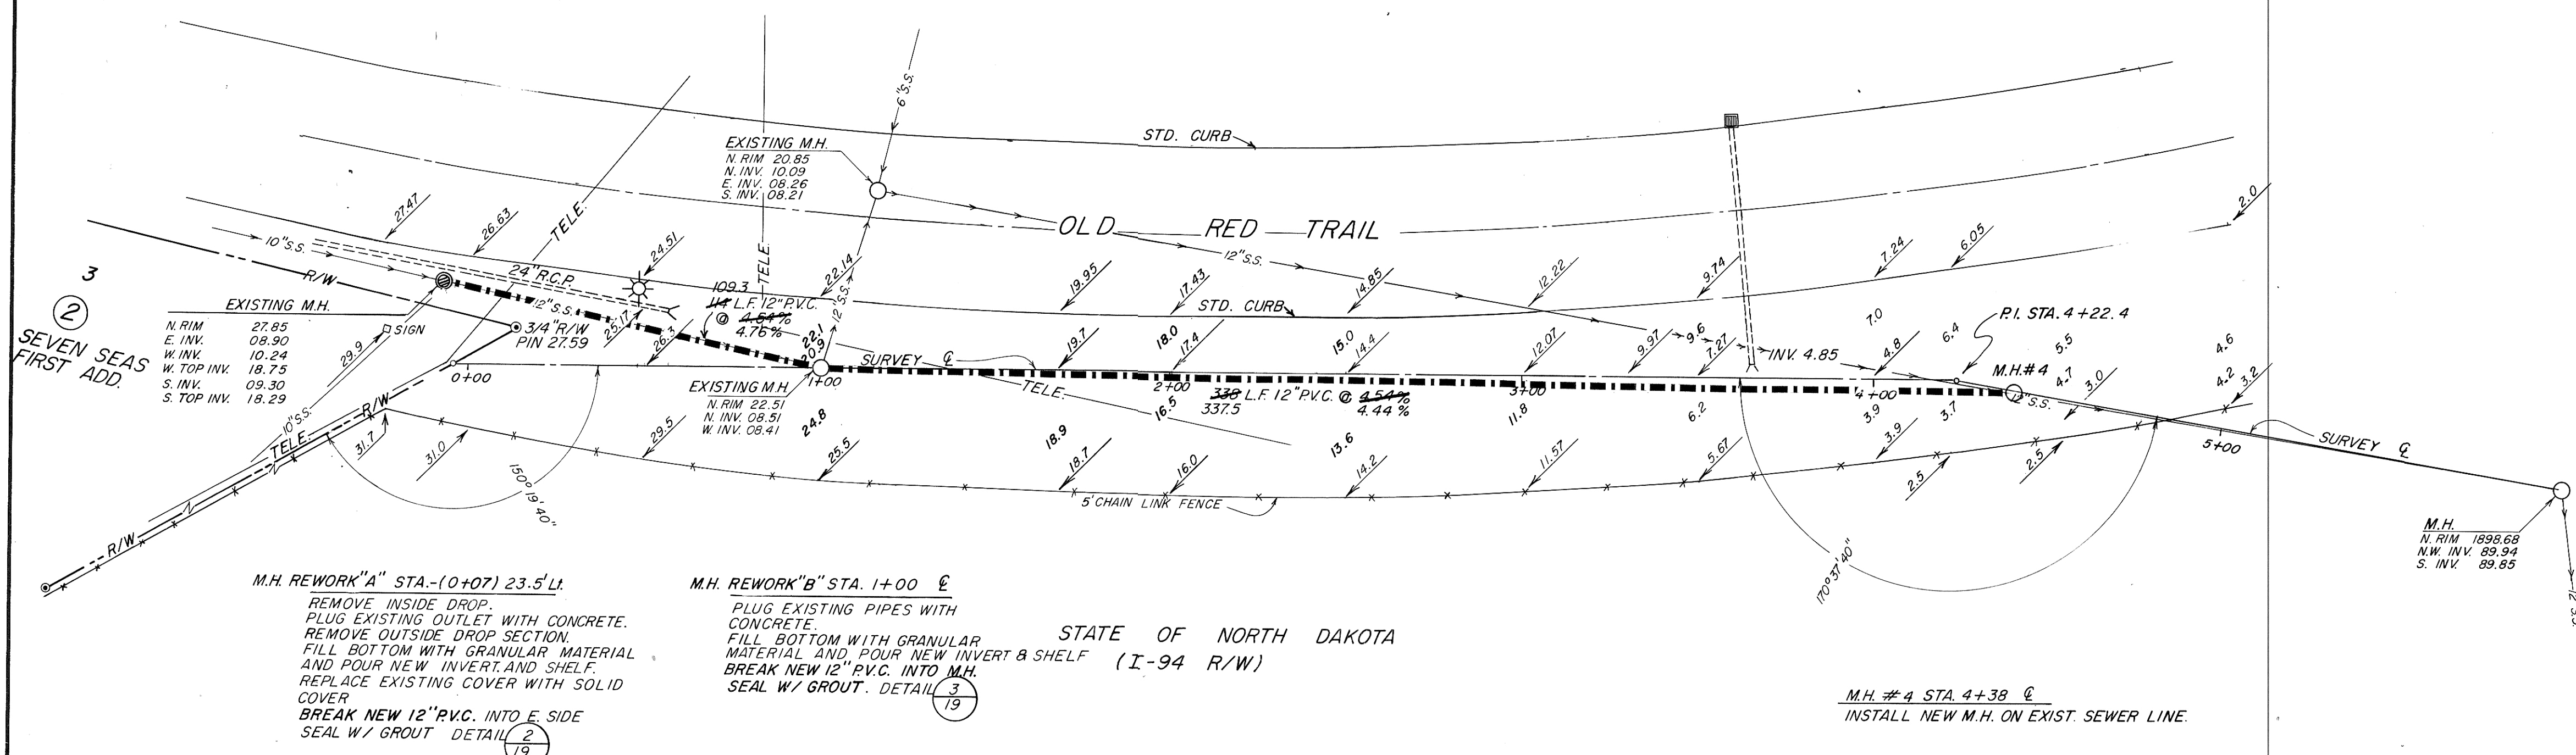
M.H. REWORK "A" STA. (0+07) 23.5' L  
 REMOVE INSIDE DROP.  
 PLUG EXISTING OUTLET WITH CONCRETE.  
 REMOVE OUTSIDE DROP SECTION.  
 FILL BOTTOM WITH GRANULAR MATERIAL AND POUR NEW INVERT & SHELF.  
 REPLACE EXISTING COVER WITH SOLID COVER.  
 BREAK NEW 12" PVC. INTO E. SIDE  
 SEAL W/ GROUT. DETAIL 2/19

M.H. REWORK "B" STA. 1+00 6'  
 PLUG EXISTING PIPES WITH CONCRETE.  
 FILL BOTTOM WITH GRANULAR MATERIAL AND POUR NEW INVERT & SHELF (I-94 R/W)  
 BREAK NEW 12" PVC. INTO M.H.  
 SEAL W/ GROUT. DETAIL 3/19

NOTE: SODDING INSTALLED AT DOWNSTREAM END OF CULVERTS
